**AUDIT OF THE EFFICIENCY  
OF THE PROCEDURE FOR  
ISSUE OF LICENCES FOR  
GEM INDUSTRY AND THE  
EFFECT OF GEM INDUSTRY  
INCLUDING THE  
ABANDONED MINES ON THE  
COMMUNITY AND  
ENVIRONMENT – 2012**

**Performance and Environment  
Audit Unit**

**Auditor General's Department**

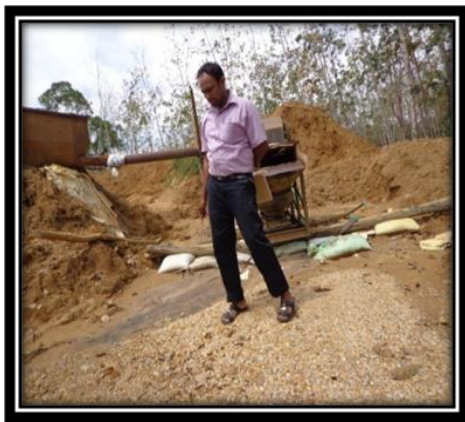
Photograph 1 : Udawatta Dambuluwana  
(2/78943)

According to the letter dated 31 August 2004 of the Director General of the National Gem and Jewellery Authority, the layer of topsoil excavated should be deposited in a manner to enable the use of topsoil to cover the top of the closed mines. Nevertheless, such instructions had not been followed in respect of Udawatta Dambuluwana, Hunuwala Manwadigahawatta, Theppanwa Ovitigama work sites. This is clearly depicted in photographs 1,2 and 3.

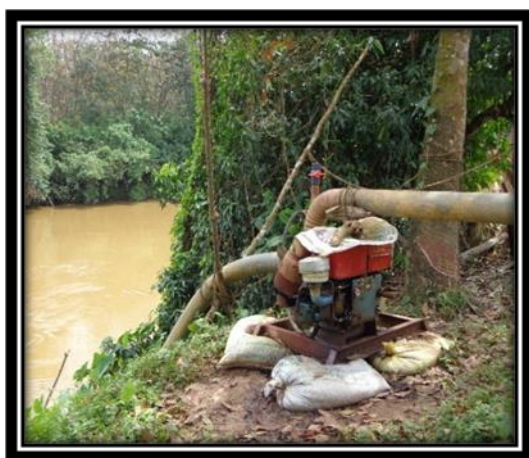
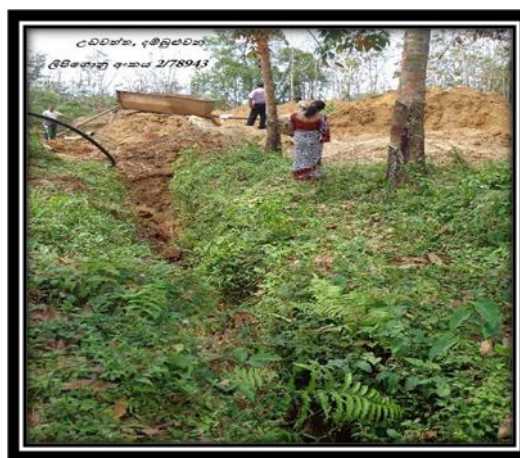
Photographs 4,5 : Udawatta Dambuluwana (2/78943)

According to the Circular No. NGJA/16-2/2012/Backhoe-1, washing of the deposits from excavations should be done without allowing the discarded water to flow into rivers, canals and brooks while a methodology for minimizing the environmental damage should be determined and followed through a report of a Mining Engineer. Nevertheless, instances of diverting such water direct to the rivers, canals and brooks were observed in respect of Udawatta Dambuluwana, Kiriellawatta, Poroduwa Pelmadulla. Details appear in photographs 4,5,6 and 7.

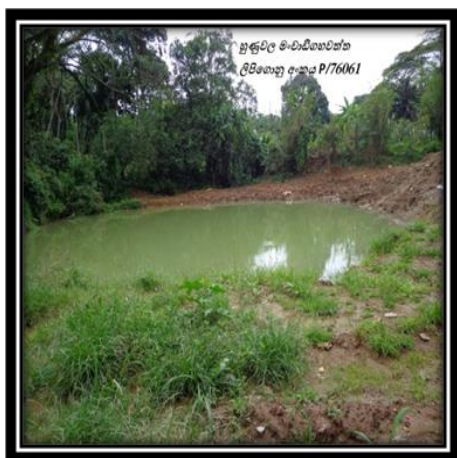
Photograph 8 : Hunuwala Manwadigahawatta (P/76061)

Instances of failure to close the mine pits after completion of gemming activities were observed and there was no evidence that the authorities concerned had paid any attention in that connection. Those pits were filled with water resulting in the breeding of mosquito larva posing a severe threat to the health of the public due to the spread of dengue and brain fever. There was evidence to prove that the recent spread of the Japanese Encephalitis disease throughout the district had been due to the above condition. The

existing position of the work sites at Hunuwala, Manwadigahawatta, Kiriellawatta, Theppanawa, Ovitigama and Pathagama Polgahawela is clearly depicted in photographs 8,9,10 and 11.

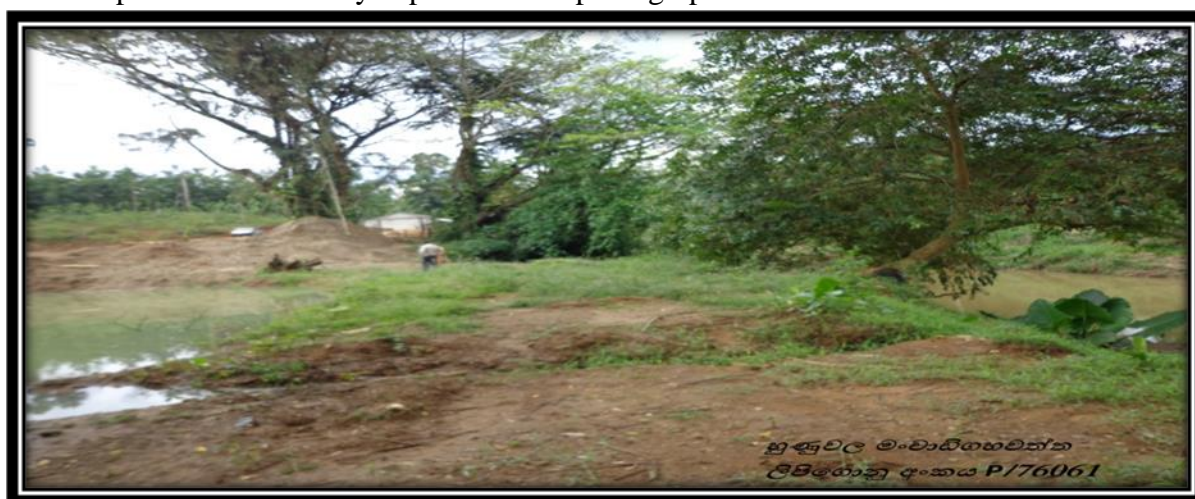
Photograph 12 : Hunuwela Manwadigahawatta

It was observed that the use of reservations made for rivers, canals, brooks and water sources for unauthorized mining had resulted in the destruction of those reservations. It was further observed from photographs 12 and 13 that it had adversely affected in community and caused severe damage to the environment.

Example 1 : Even though the letter dated 31 August 2004 of the Director of the National Gem and Jewellery Authority required setting apart a reservation of 150 metres for the Hunuwala Manwadigahawatta river in the area of the Opanayaka Divisional Secretariat, a reservation of 40 feet only had been set apart. This is clearly depicted in the photograph 12.

A reservation of 33 feet is set apart for a river under a normal gemming licence while a reservation of 150 feet is set apart for a river under mechanized excavation of mines. If the Implementation Officers report on mines excavated in the reservations during supervision those will be punished in terms of Circular 121-6. If the same offence is committed in 03 instances, licence will be cancelled and the deposit will be confiscated. Conciliation fees were recovered in connection with the excavation of mines in the river reservation of Hunuwala Manwadigahawatta referred to in the report and instructed to close the mines excavated in the reservation.

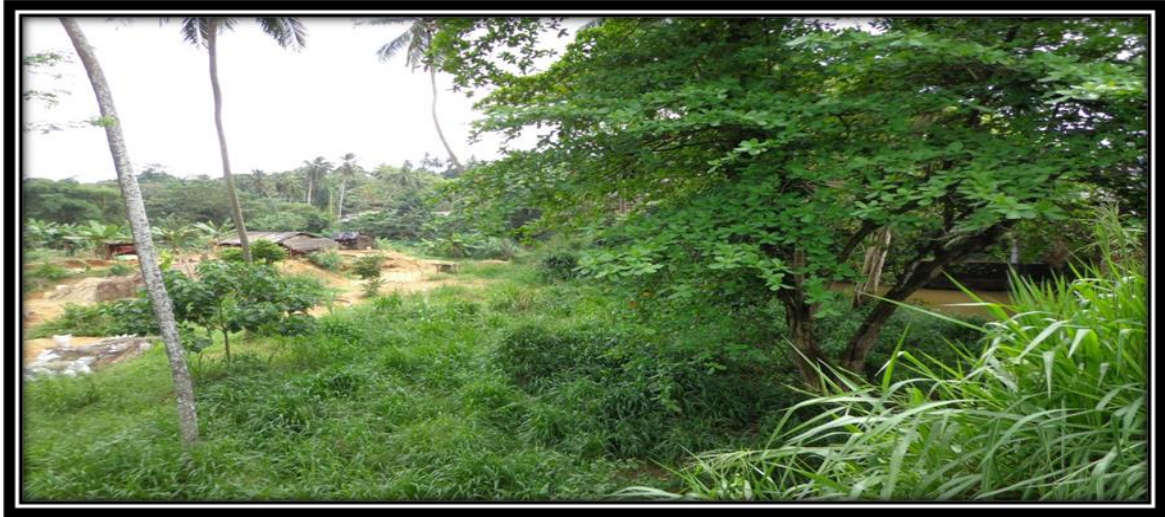
Photograph 13 : Kahawaththa

Example 2 : Gemming had been carried out without setting apart an adequate reservation for the Weganga situated near Kahawatta Town. The reservations made for the bridge over the Weganga flowing through Kahawatta Town had been used for unauthorized gemming and it was observed that it had posed a severe threat to be continued existence of the bridge.

The excavation of mines under the licence for the land near the bridge in the Kahawatta Town is done by setting apart the reservation made for the bridge. Nevertheless the excavation of mines under this licence is suspended at present for breach of conditions.

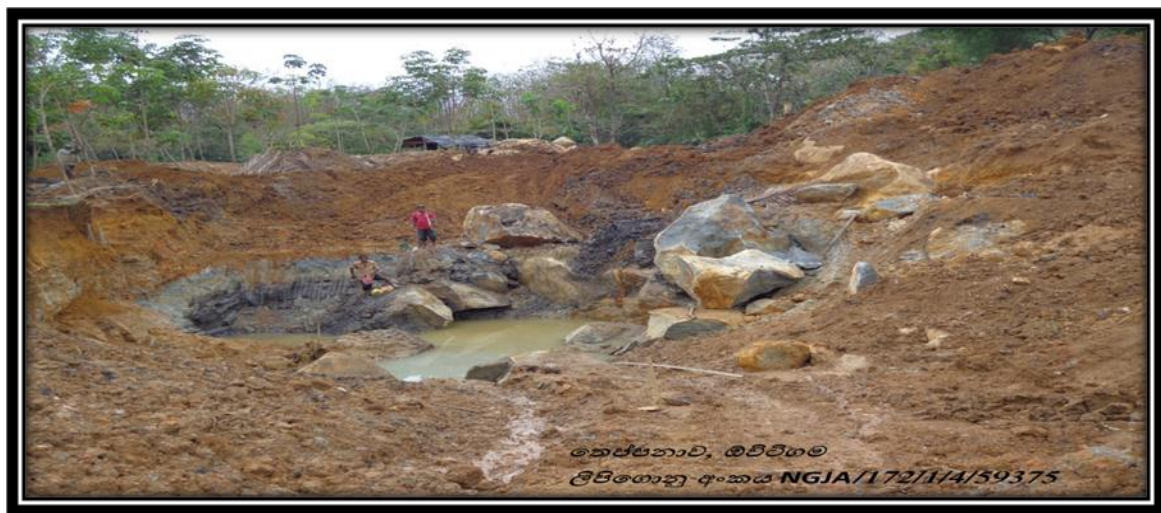
Photograph 14

According to condition 7 of the licence, when explosives have to be used for removal of rocks from gemming sites, approval therefor has to be obtained in advance. Nevertheless, such approval had not been obtained for the work site at Theppanawa, Ovitigama situated in the area of Kuruwita Divisional Secretariat. Kuruwita Divisional Secretariat had reported that the use of rock blasting and backhoe machines had damaged houses. This position is clearly depicted in photograph 14.

Rock blasting without obtaining approval is a breach of the conditions of licence. Action in terms of Circular No. 121-6 will be taken against the licence holder for the breach of conditions of licence.

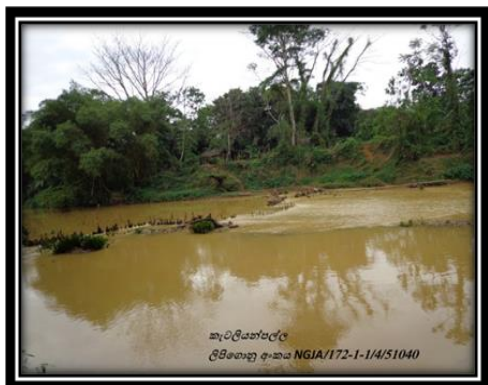
Photograph 15

Gemming industry carried out through extraction mines as well as mining by using reservations also were observed. This practice had led to silting of all riverbeds in the district causing flood threats to the community. This results in health problems to the people whose source of water for basic needs is the river. It was also observed that this condition could affect large scale water

supply projects. It was further observed that to the unauthorized extraction mines could deviate the courses of rivers thus causing severe environmental problems. This is further observed from the photographs 15, 16 and 17.
